Limited Visual Dam Safety Inspection Summary Report

MA-059

Upper Field 30 Reservoir

May 2006

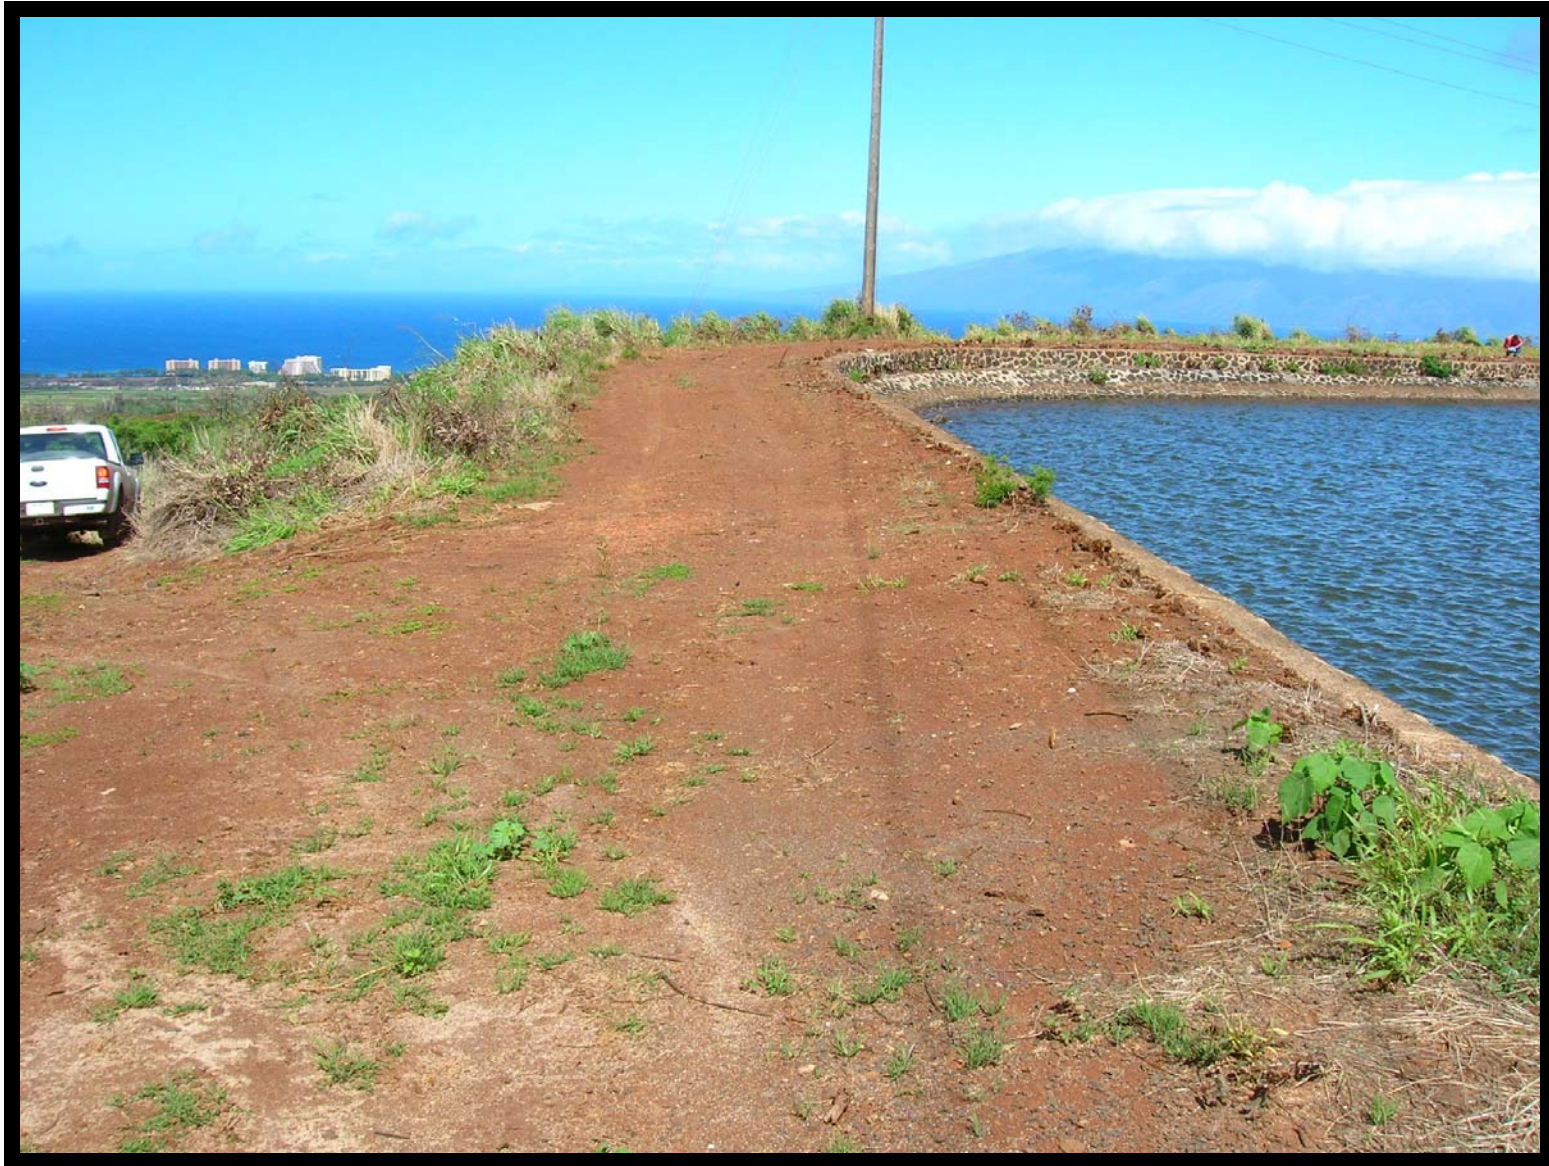
059 crest

Cracks were not observed, however the crest was not entirely visible.

Sinkholes were not observed, however there were several low areas on the crest.

Heavy vegetation was observed on the edges of the crest. These were primarily small woody vegetation and high grass.

- a. The dam crest appeared to be in satisfactory condition, no correction actions are required at this time.

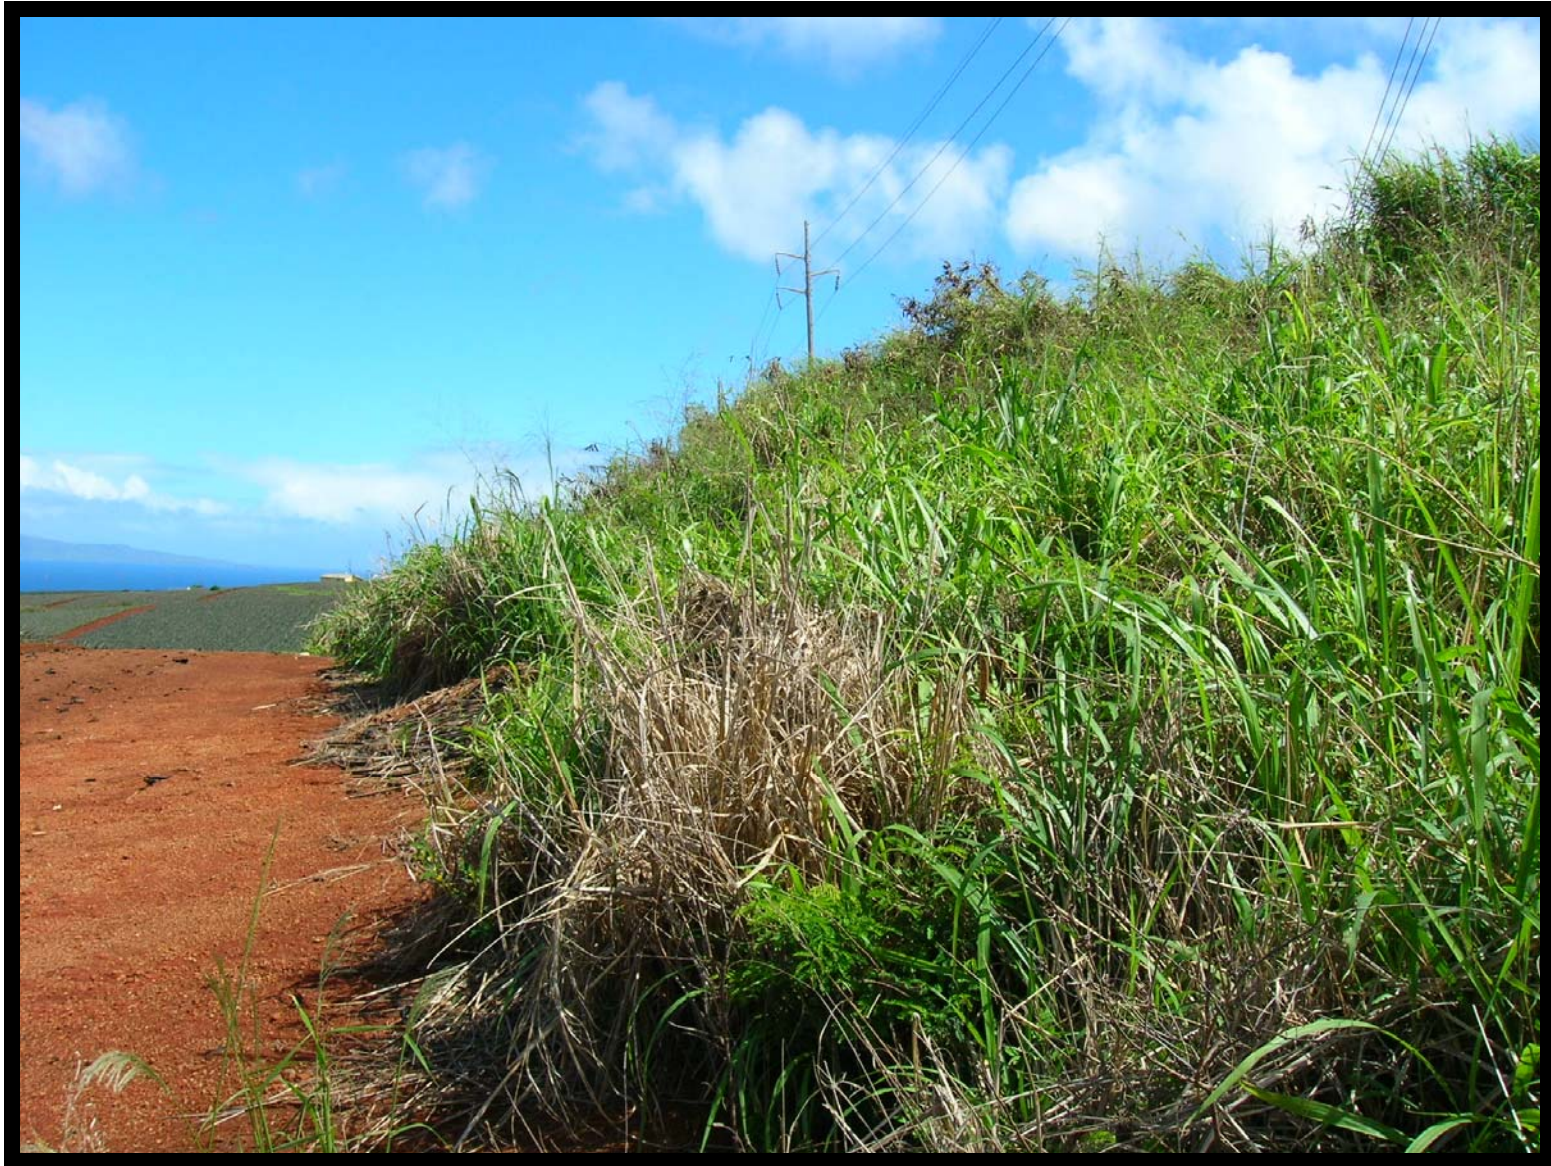
059 downstream slope

The downstream slope was in poor condition and not visible due to heavy vegetation.

Vegetation was observed on the downstream slope. The majority of the vegetation was woody trees ranging from 2" to 2 feet in diameter.

- a. The downstream slope appeared to be in fair to poor condition and requires corrective action.
- b. Gully erosion was observed on the slope, which requires maintenance and repair. Repair scarps.
- c. The down stream slope was not visible due to high grass and bush vegetation. Clear high vegetation and maintain low to enable easy visual inspection.
- d. The slope was very steep, around a 1 to 1 slope; further study is required to verify slope stability.

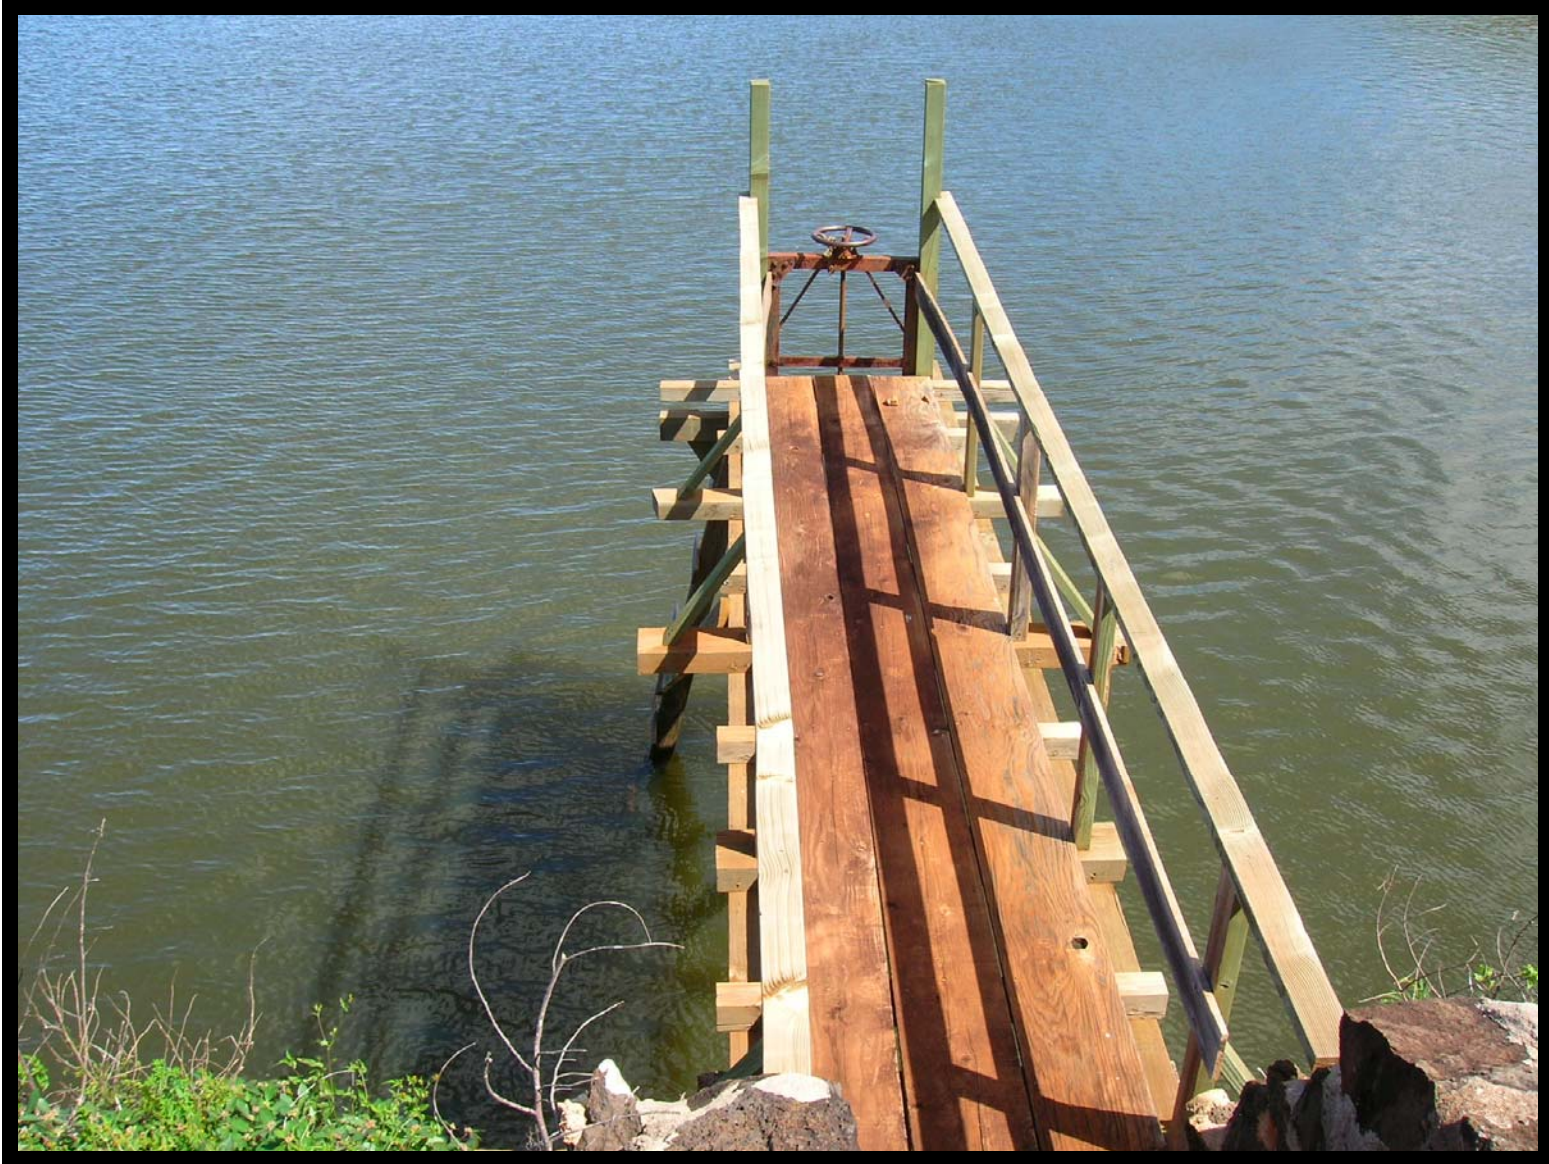
059 inlet

There are two inlet pipes of unknown type and size and an 8ft by 4ft channel feeding the channel. The intake has the ability to be shut off or diverted away from the reservoir during periods of heavy rains. This is done manually.

- a. The intake works were not tested.
- b. The intake works appeared to be in satisfactory condition, no corrective actions are required at this time.

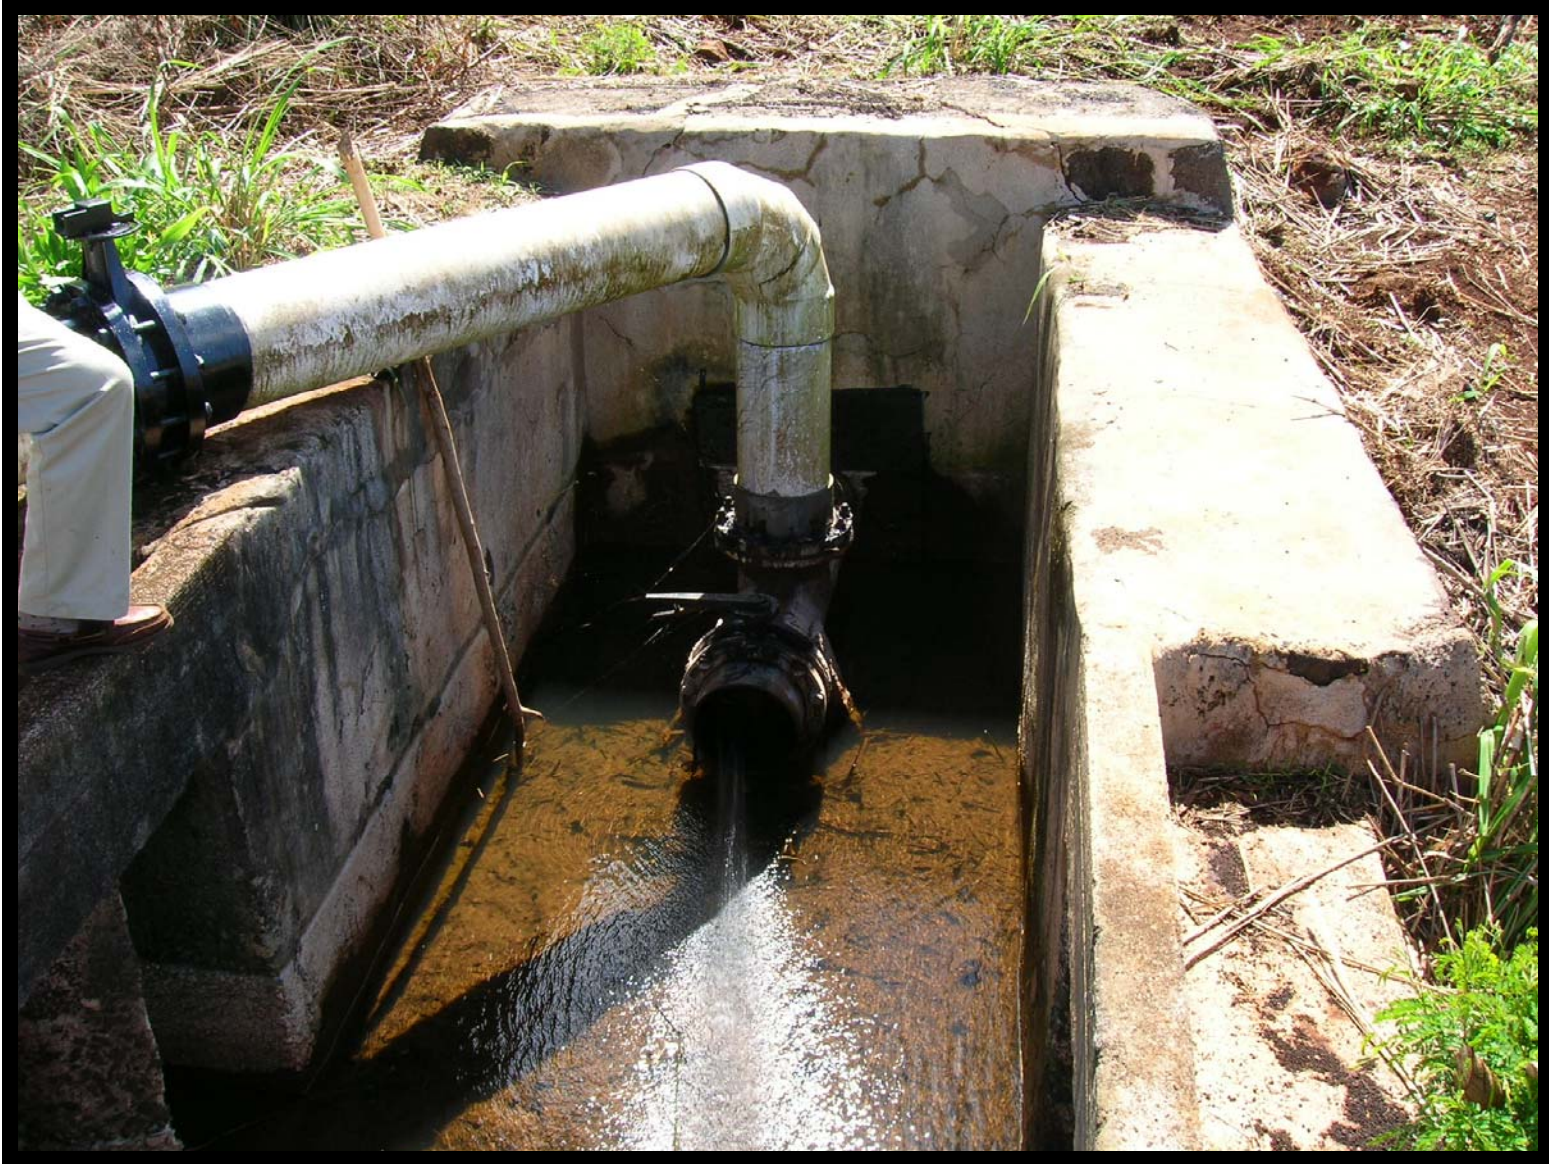
059 outlet

Not inspected in detail, not tested. The outlet works was controlled via a gate valve on the upstream side of the dam. Seepage was not observed flowing near the exit of the outlet works from the dam.

- a. The outlet works were not tested.
- b. The outlet works appeared to be in satisfactory condition, no corrective actions are required at this time.

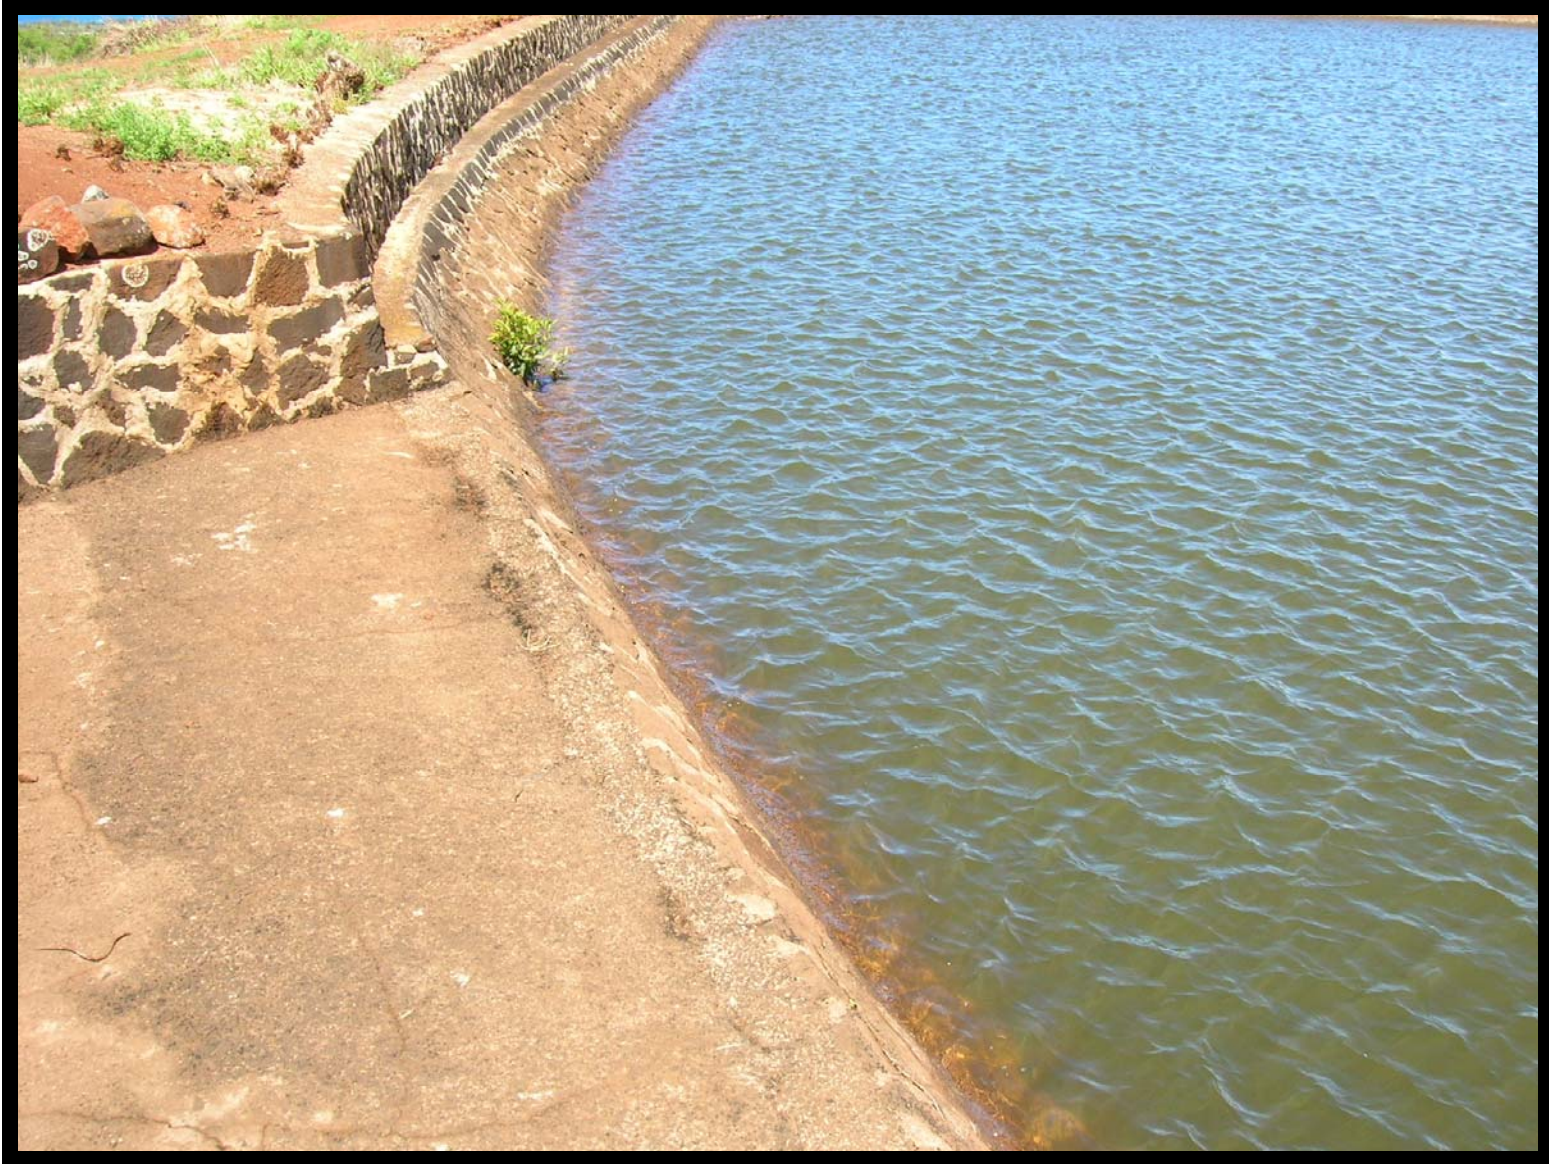
059 spillway

There was no erosion observed near the spillway.

- a. The Spillway appeared to be in satisfactory condition, no corrective actions are required at this time.

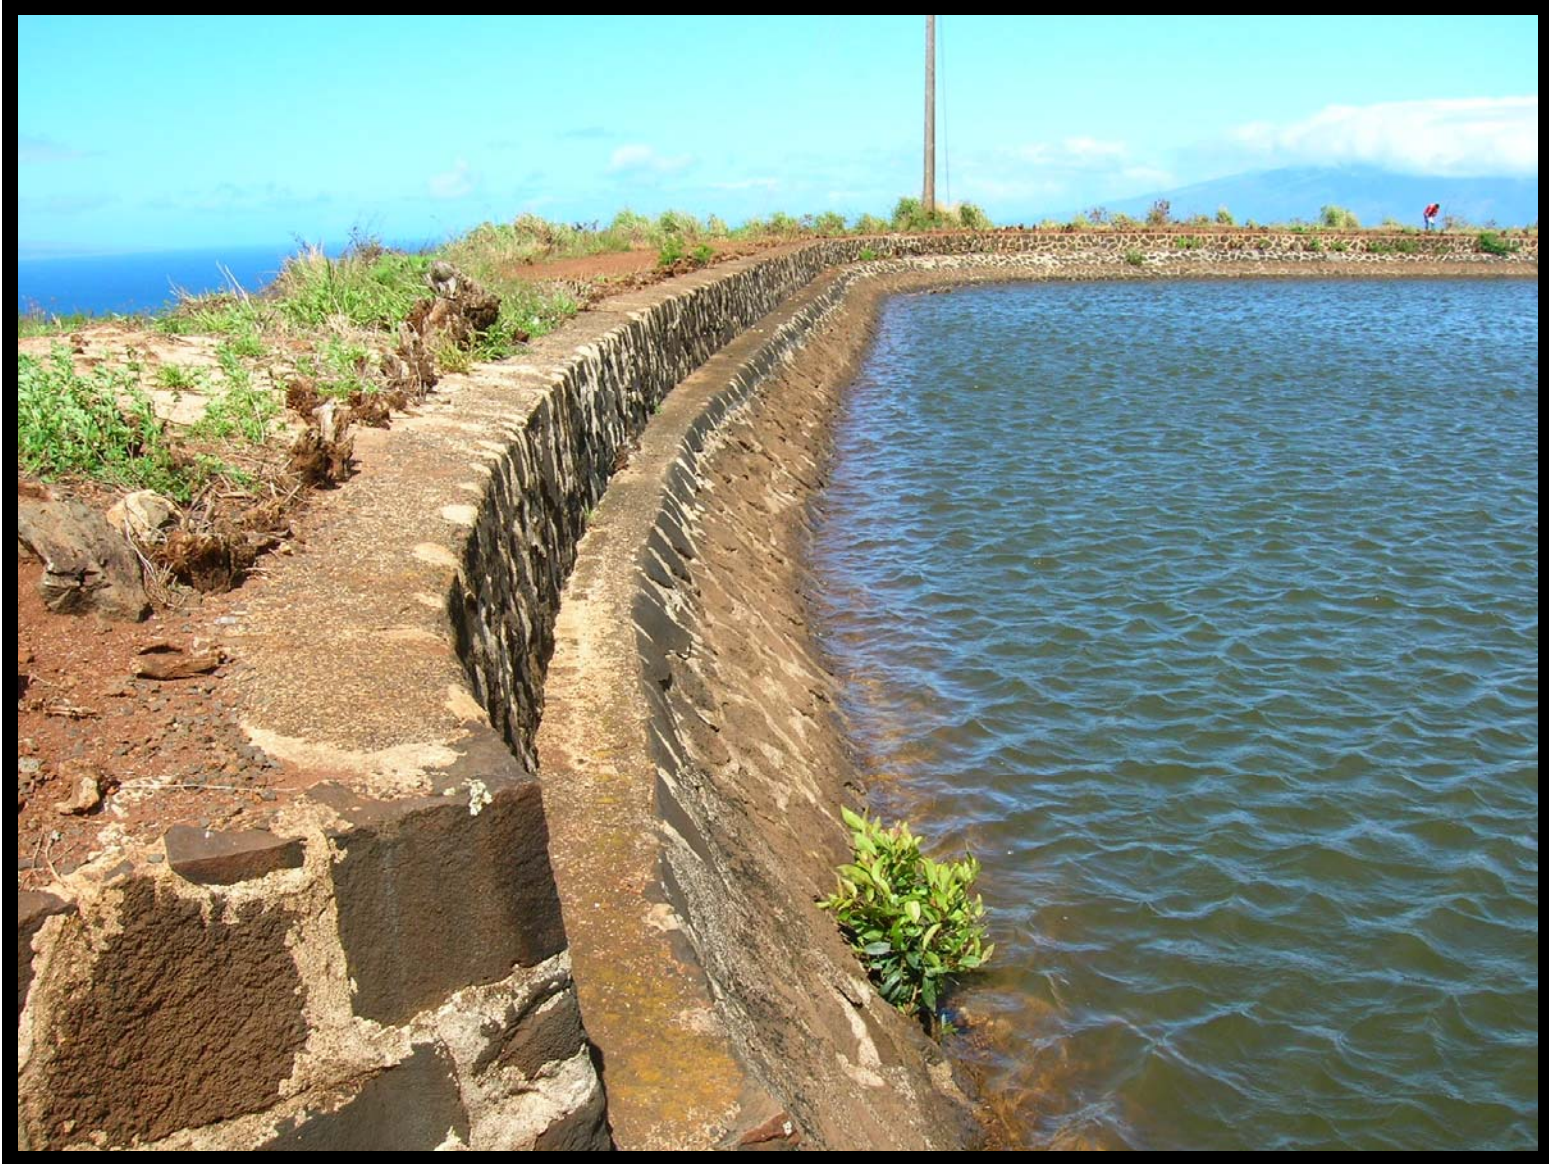
059 upstream slope

A grouted rip rap slope protection was observed. Erosions were not observed, the slope was not entirely visible.

Cracks were not observed; the slope was not entirely visible.

Sinkholes were not observed, the slope was not entirely visible.

- a. The upstream slope appeared to be in satisfactory condition.
